# Debris/Ice/TPS Assessment and Integrated Photographic Analysis of Shuttle Mission STS-71

*Gregory N. Katnik, Barry C. Bowen, J. Bradley Davis*

**27 June 1995**

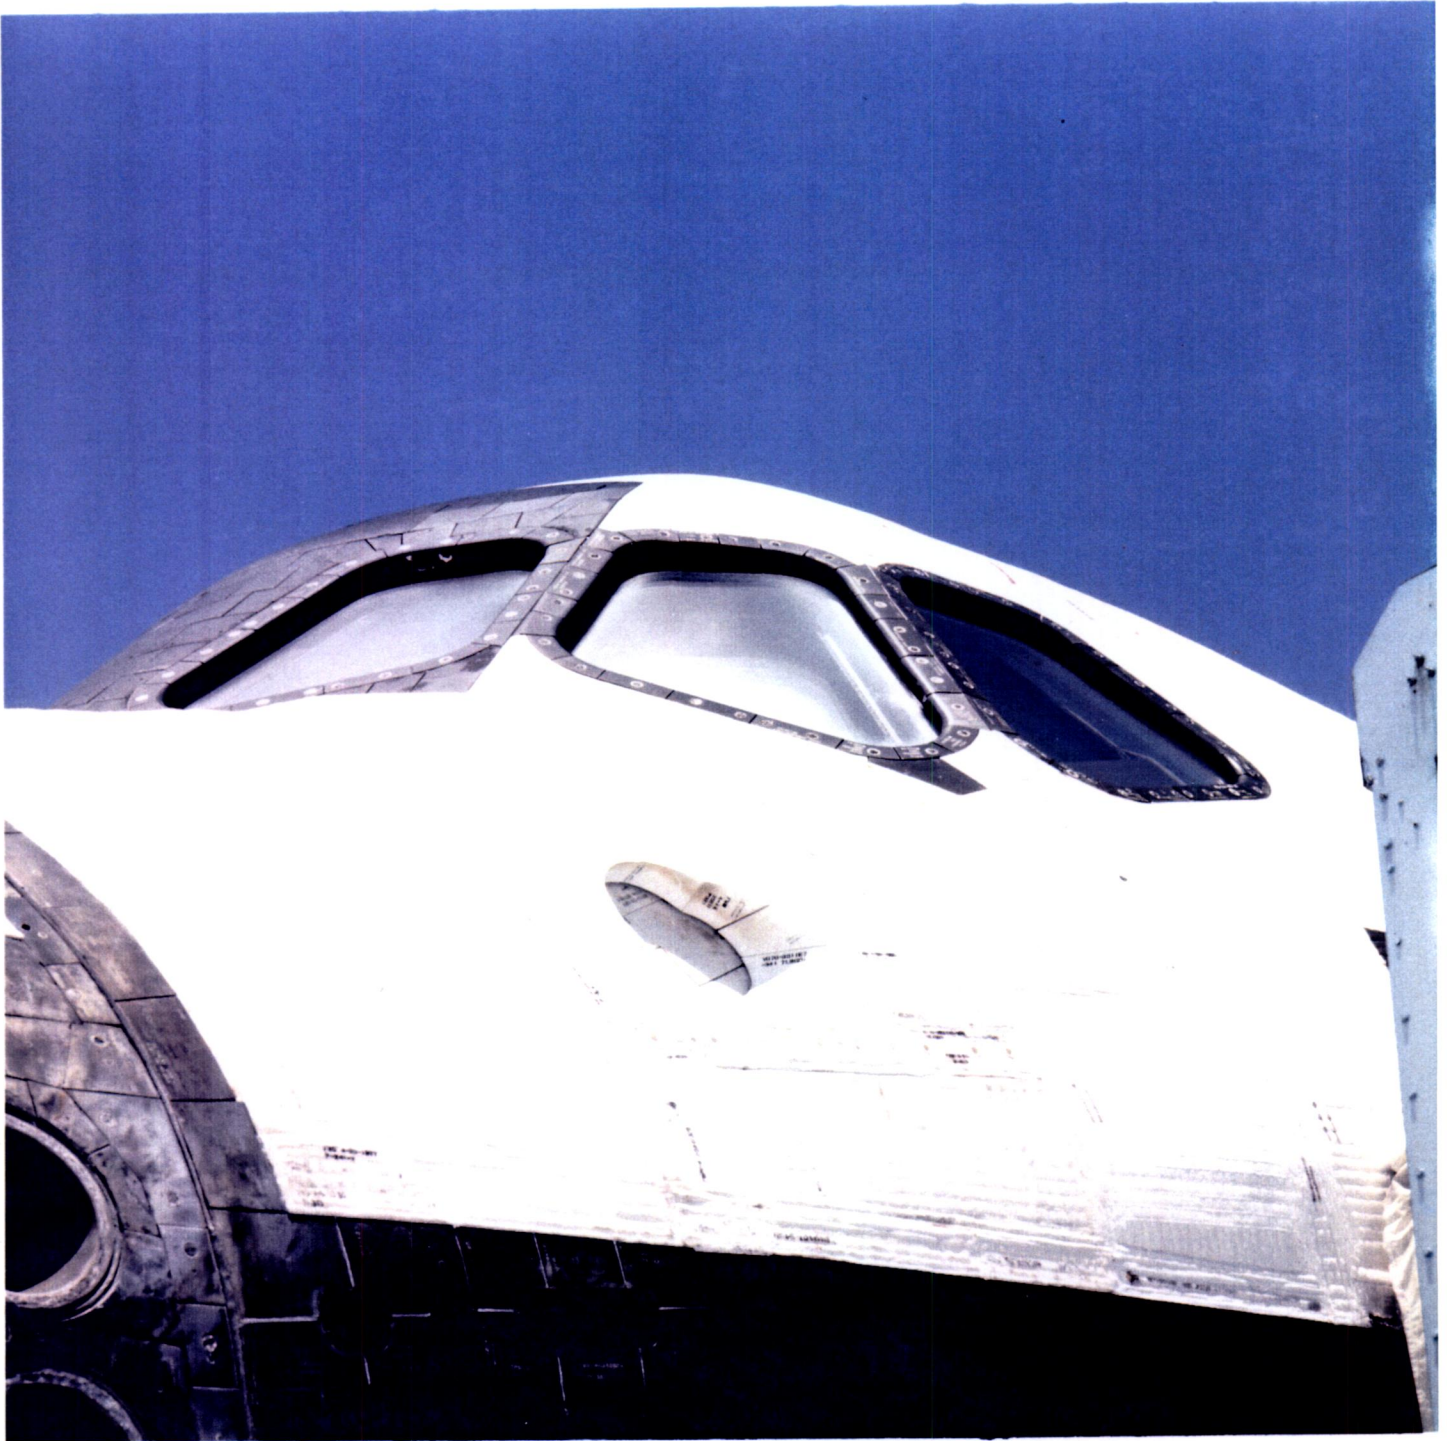
**Photo 31: Orbiter Windows**

Orbiter windows #3 and #4 exhibited moderate hazing. A light haze was present on the other windows. Tile damage on the window perimeter tiles was significantly less than usual. Four damage sites in a perimeter tile above window #3 was not caused by a debris impact. A previously repaired area had shaken loose during flight. A concerted effort had been made to minimize the RTV used for attaching paper covers to FRCS thrusters.

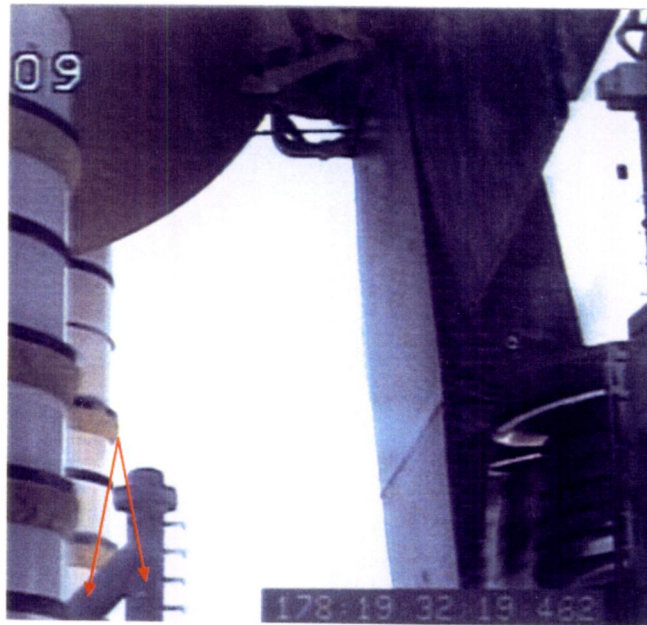
Figure 2.1.1.1 (B) Debris Strike to LSRB at 0.4 Seconds MET

Normal ice debris was noted falling from the LH2 and LO2 ET/Orbiter umbilical disconnect areas at SSME ignition through liftoff. A white piece of debris from the ET/Orbiter umbilicals was seen to strike the umbilical well door sill at T-3.2 seconds (Figure 2.1.1.1 A). Three small light colored pieces of debris appeared to travel upwards and strike the LSRB at 0.4 seconds MET (Figure 2.1.1.1 B). A small white piece of debris appeared to strike the ET aft dome near the LO2 ET/Orbiter umbilical at 0.7 seconds MET (Figure 2.1.1.1 C). None of the debris strikes were seen to damage the launch vehicle. No follow-up action was requested.

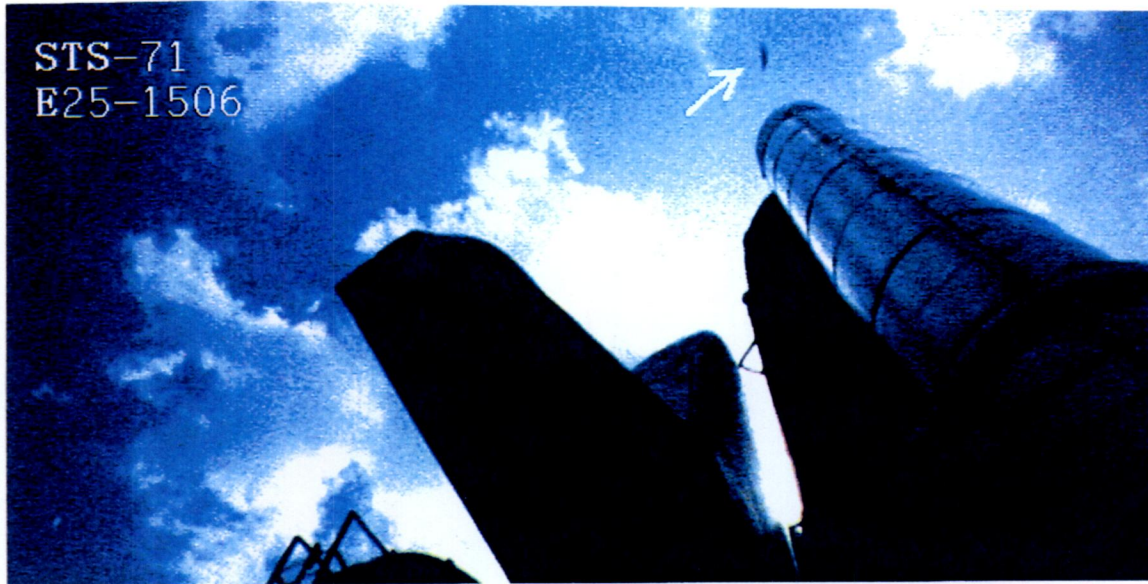
**Figure 2.1.1.4** Dark Debris Near RSRB at T-3.5 Seconds MET

A dark piece of debris was seen moving from the top of the view in front of the RSRB and fell along the underside of the Orbiter. This debris was not seen to contact the vehicle. No follow-up action was requested.

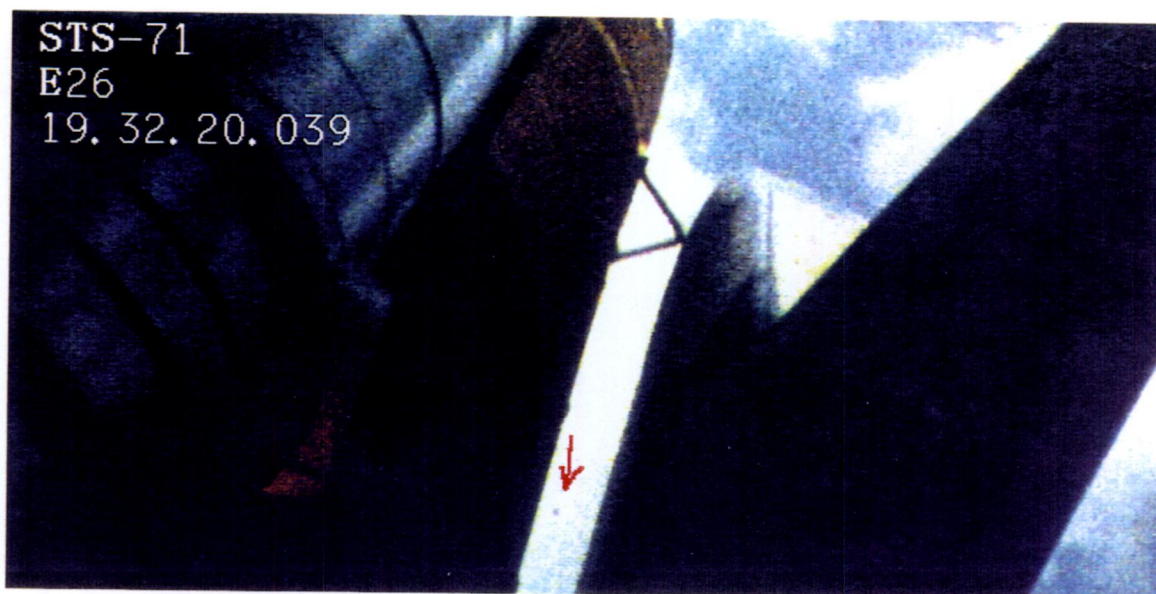
**Figure 2.1.3.1** Debris at 1.1 Seconds MET

A small dark piece of debris was seen falling between the Orbiter and the ET at liftoff. The debris was first seen forward of the ET/Orbiter umbilicals. The debris was not seen to contact the launch vehicle. No follow-up action was requested.

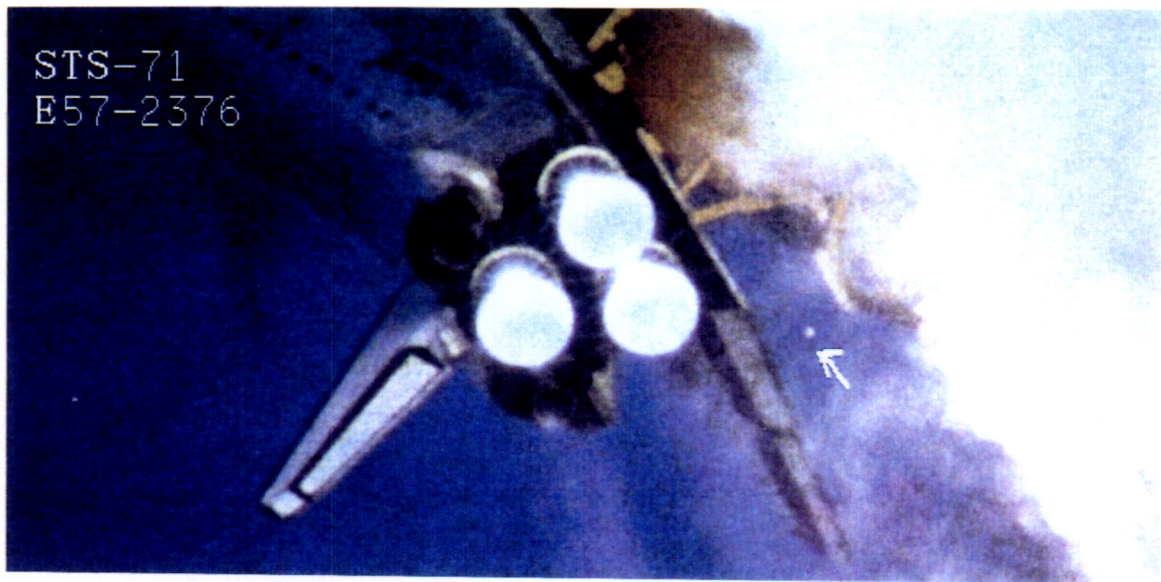
Figure 2.1.3.4 Debris at 17.3 Seconds MET

A single light-colored piece of debris was seen falling aft of the body flap. The debris was not seen to contact the vehicle. No follow-up action was requested.

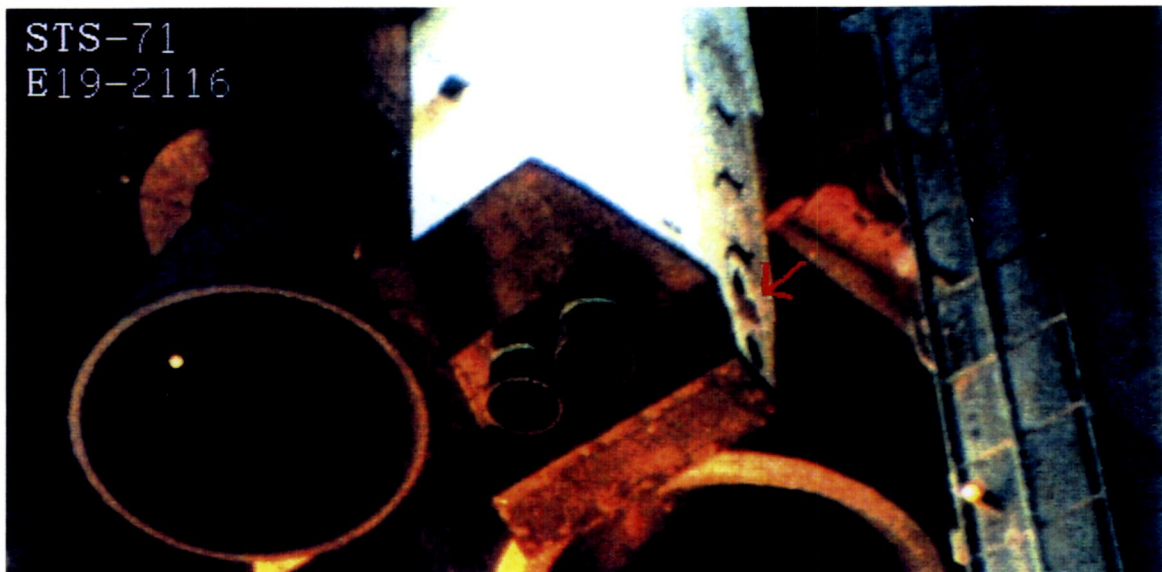
**Figure 2.2.1** Dark Orange Vapor Coming from R2U RCS Thruster

Dark orange-colored vapor was seen coming from the R2U RCS thruster when its paper cover tore during SSME ignition (T-4.5 seconds). KSC reported these vapors to be oxidizer vapors and stated further that this thruster had exhibited signs of a very small leak prior to launch. No follow-up action was requested.

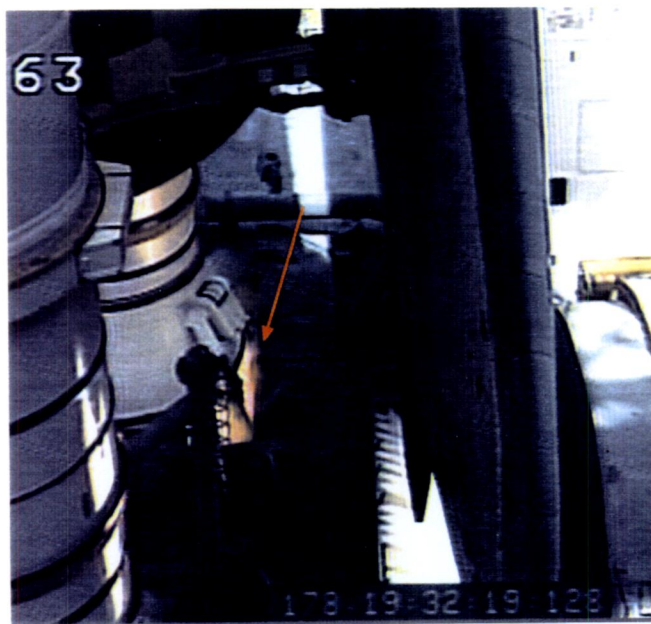
**Figure 2.2.11** Flash of Light below RSRB Aft Skirt at 0.1 Seconds MET

A reflection or flash of light was seen below the RSRB aft skirt and reflecting off the base of the ET at 0.1 seconds MET. No follow-up action was requested.

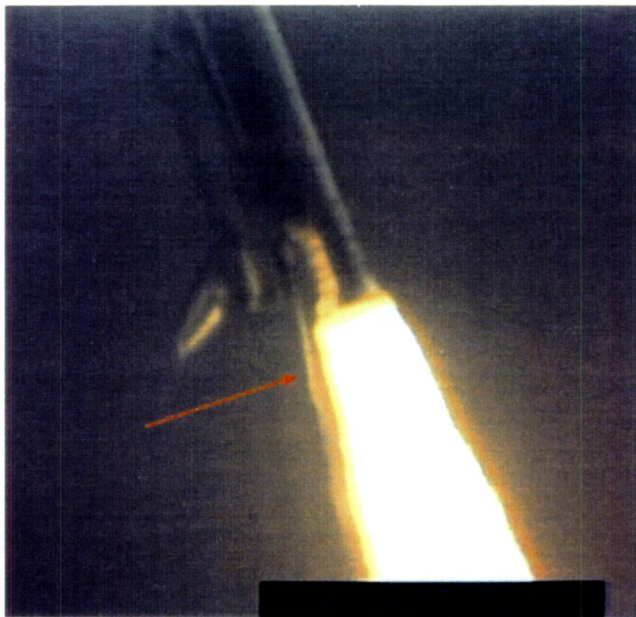
**Figure 2.3.1** White Stream off Wing Tip

A white stream, possibly a contrail, was seen originating from near the Orbiter starboard wing tip at 17.3 seconds MET. No follow-up action was requested.

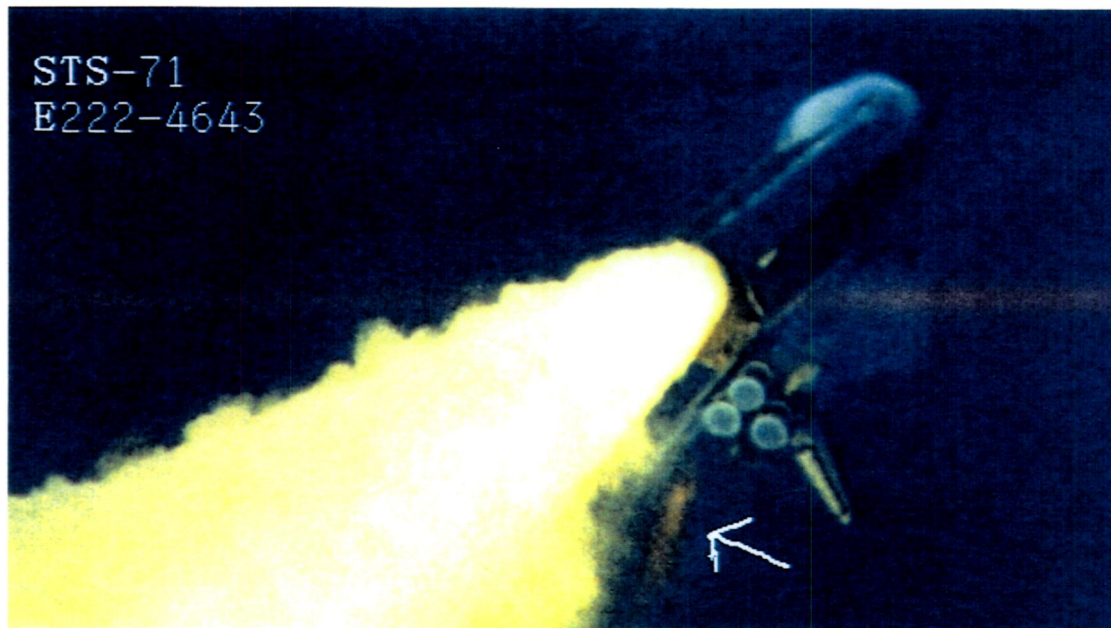
**Figure 2.3.3** Flare in SSME Exhaust Plume

Orange-colored flares were seen in the SSME exhaust plume after liftoff (24.2, 25.6, 42.6, and 42.8 seconds MET) (E223). The flare at 42.6 seconds MET was also seen on E222 (picture above). An orange-colored flare was seen in the SSME exhaust plume at 44.7 seconds MET (E207). No follow-up action was requested.

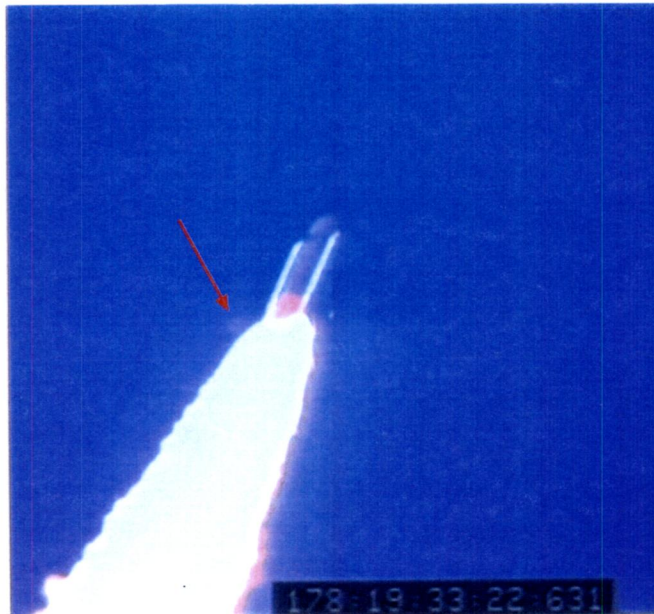
**Figure 2.3.6** Vapor-like Object along Exhaust Plume

A vapor-like object, first seen near the right side of the SLV, fell aft along the SRB exhaust plume at 63.5 seconds MET.

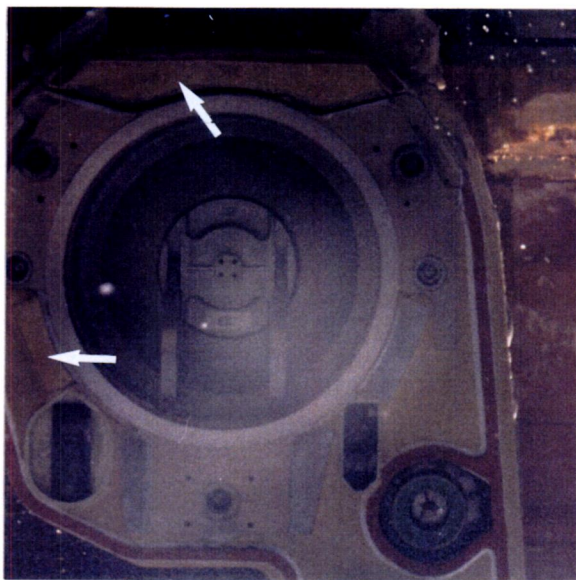
**Figure 2.4.1 (A) Missing Lightning Contact Strips**

The lightning contact strip at the 12 o'clock position forward of the LO2 17 inch line (orifice) is missing. A second contact strip was missing at the 8 o'clock position (Figure 2.4.1 A). LO2 umbilical lightning contact strip(s) were noted missing on STS-57, STS-58, STS-65, STS-66, and other previous mission umbilical well films.

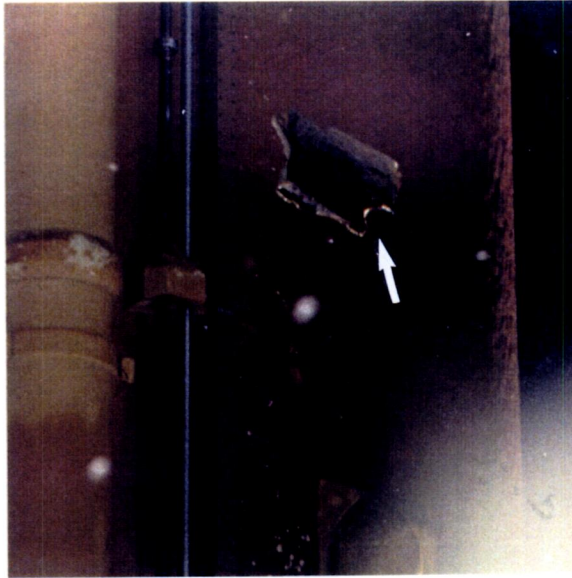
**Figure 2.4.1 (B) Irregular Shaped Debris**

An irregular shaped piece of debris which appeared to be dark on one side and light on the other (not ice), was visible in frames 19 - 24 (Figure 2.4.1 B). KSC stated that this debris may be a piece of foam, possibly from the intertank area.

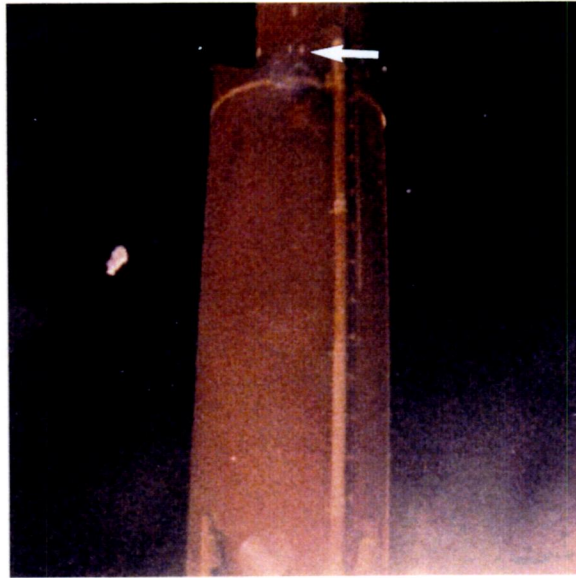
**Figure 2.4.1 (C)** Eight White Marks (Probably Divots)

Approximately eight white marks, probably divots, are visible on the ET intertank TPS forward of the bipod. Four of the marks are linear shaped and are at least eighteen inches in length (Figure 2.4.1 C).

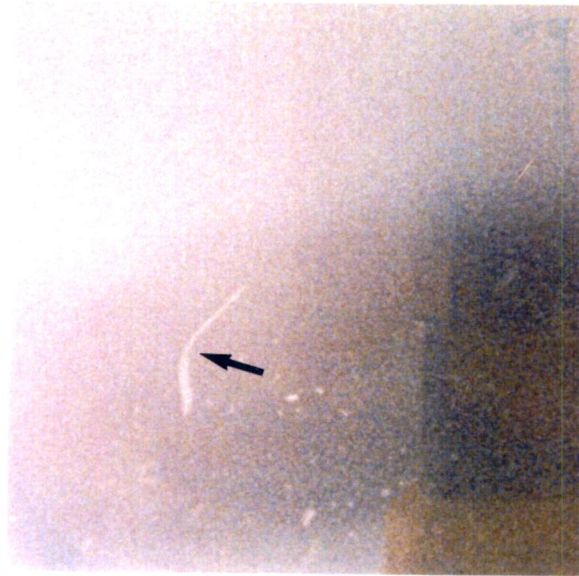
**Figure 2.4.1 (D) Strap-like Debris**

A strap-like piece of debris was seen coming from behind the electric cable tray during ET structural separation (Figure 2.4.1 D). KSC stated that the strap-like object was probably white RTV.

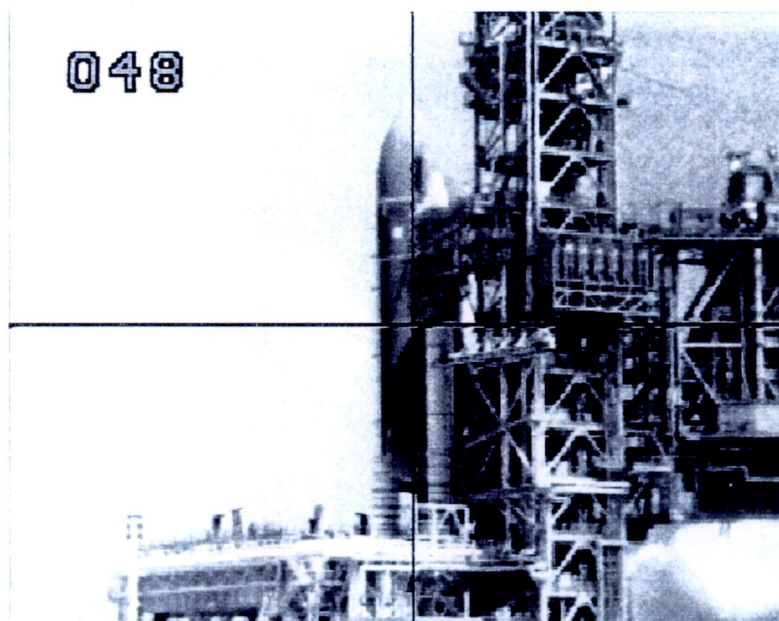
Figure 1 Frame from video camera showing light flash on SRB

A flash of light was noted on the right SRB during booster ignition. Figure one is a video frame from camera OTV-048 showing the event.

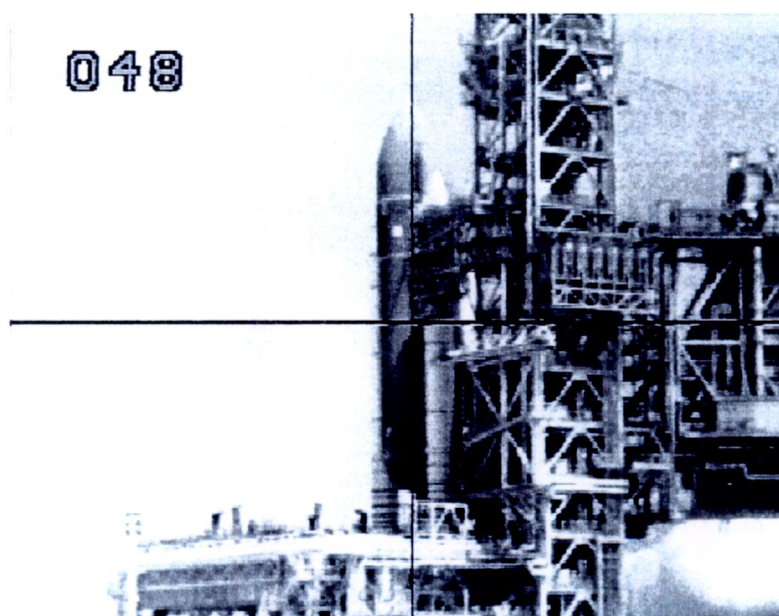
Figure 2 Video frame prior to flash event

Figure two is a frame from camera OTV-048 prior to the event and is used for comparison.

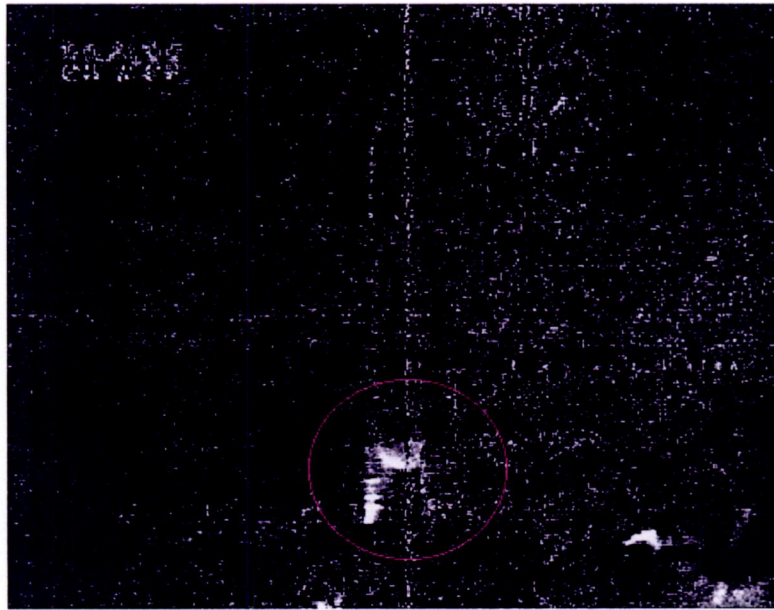
Figure 3 Result of subtraction of video frames

These two images were subtracted from each other to show the areas that were illuminated from the flash. This result is shown in Figure three.

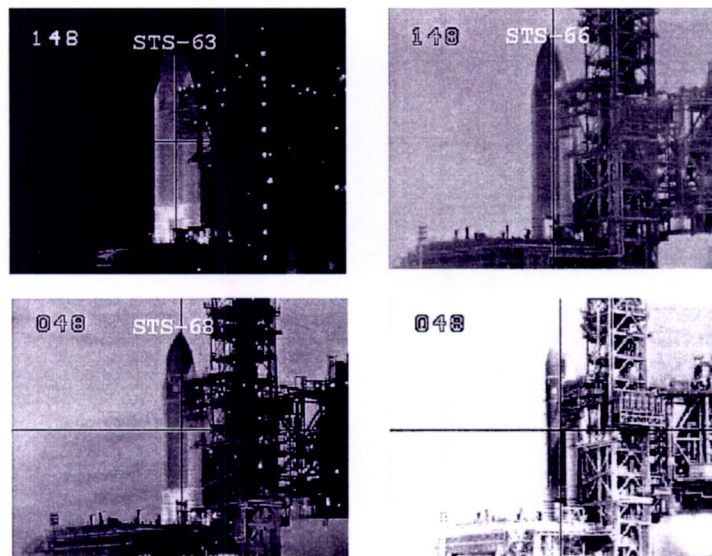
Figure 4 Comparison with other launches

The image in Figure four shows a comparison of video frames of four different launches showing the event described above.

Lighting conditions are a determining factor in whether the flash is discernible in single frame. The flashes are very visible while viewing the video tape.

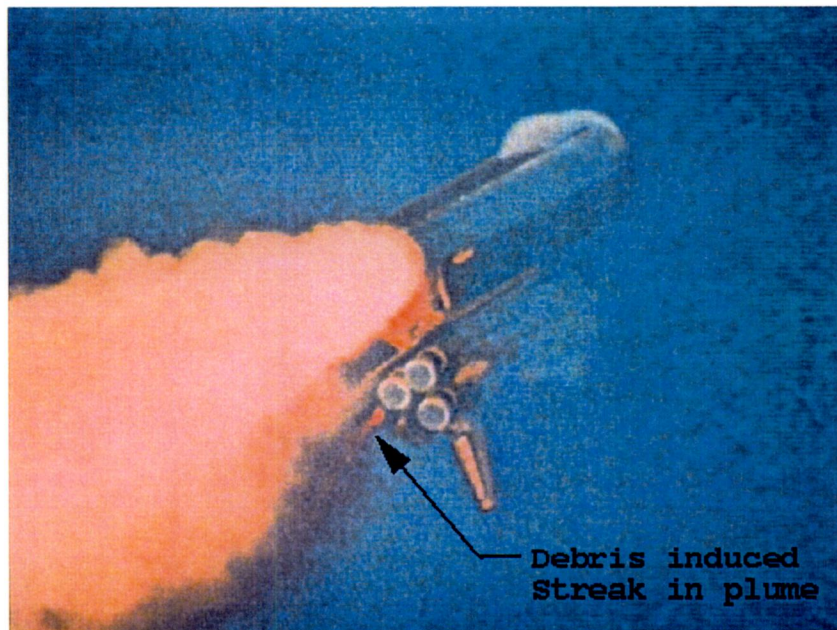
Figure 8 Debris induced streak in SSME plume

There were several debris induced streaks noted in the SSME plume during ascent. Figure eight is a frame taken from tracking camera E-222 showing one of the larger of these streaks.

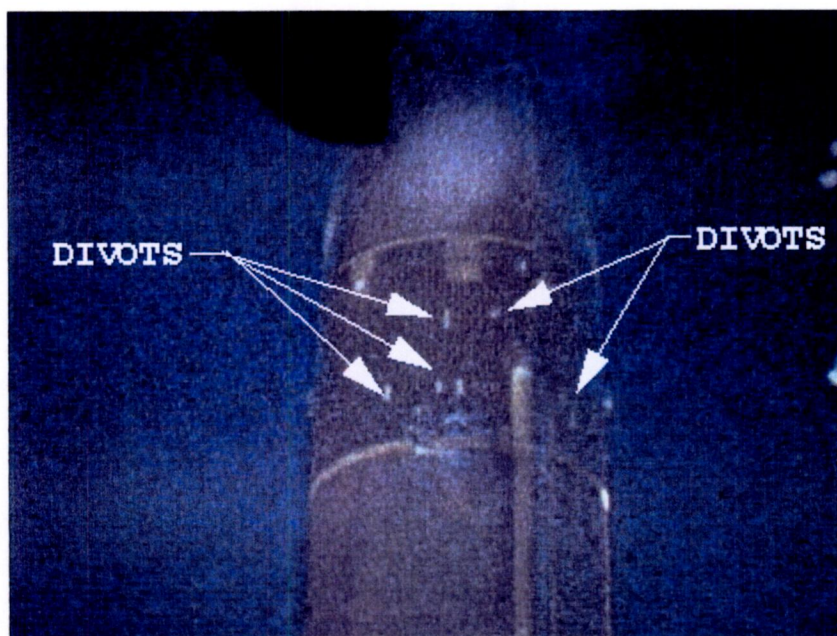
Figure 9 ET TPS divots

The umbilical well films of the external tank revealed TPS divots on the intertank stringers. Additional TPS damage is also visible near the base of the bipod strut. These type

divots have been observed before and corrective measures have been instituted for future tanks effective on ET-74 resulting from an earlier IFA. Figure nine is a film frame from the 16mm umbilical well camera of these divots.
